Van's RV-10 Service Bulletin

RAA

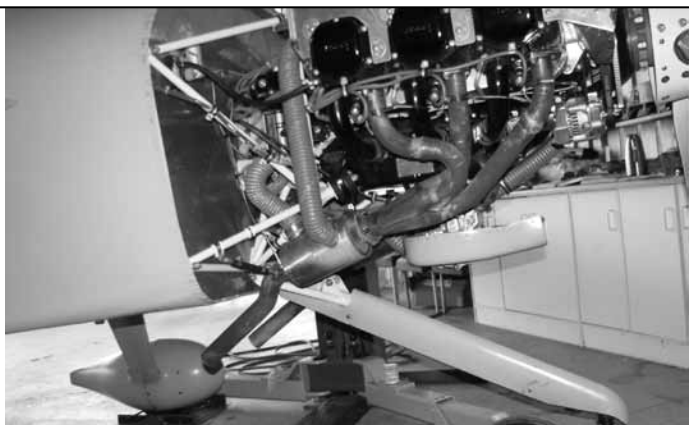
THE NOSEGEAR OF THE RV-10 is a third class lever that compresses an elastomeric shock absorber against a socket that is part of the engine mount. In some examples the socket has experienced cracking and Vans has issued SB14-8-29, details of which are available on the www.vansaircraft.com website.

-
- From top down: 1) The nosegear hinges to the engine mount at the base of the firewall;
2) The socket area on this plane has had the powder coat removed to inspect for cracks.
3) The steel reinforcement plate must be painted...
4) ...and dropped on top of the shock before reinstalling it to the engine mount*

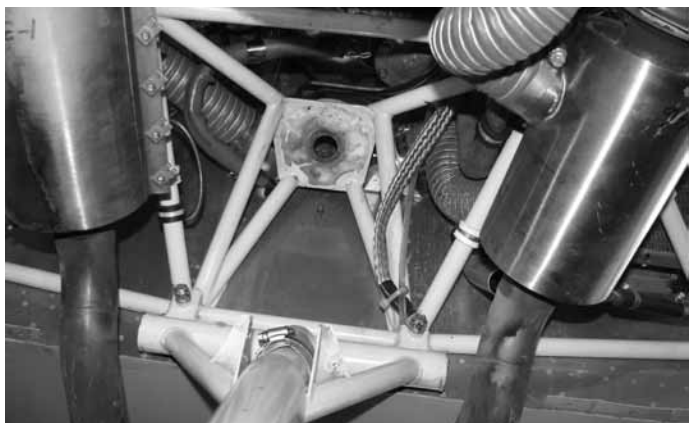
The procedure is to take the load off the nosegear by tying the tail down so that the shock absorber unit may be removed. A careful inspection of the socket of the engine mount is to be carried out, and for this the powder coat paint may have to be removed either by abrasion or by the use of a chemical paint stripper. In some cases there will be cracks emanating from the centre hole that accepts the top end of the shock absorber unit. To date this has happened only to aircraft that have had rough field operations.
