Van's RV-10 Service Bulletin

RAA

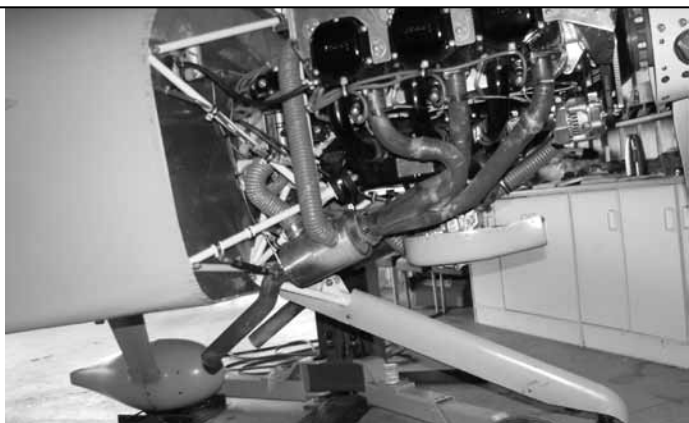
-
- From top down: 1) The nosegear hinges to the engine mount at the base of the firewall;
2) The socket area on this plane has had the powder coat removed to inspect for cracks.
3) The steel reinforcement plate must be painted...
4) ...and dropped on top of the shock before reinstalling it to the engine mount*

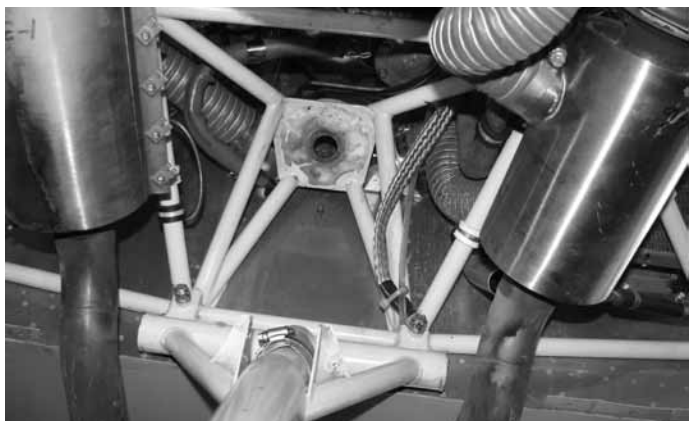
The procedure is to take the load off the nosegear by tying the tail down so that the shock absorber unit may be removed. A careful inspection of the socket of the engine mount is to be carried out, and for this the powder coat paint may have to be removed either by abrasion or by the use of a chemical paint stripper. In some cases there will be cracks emanating from the centre hole that accepts the top end of the shock absorber unit. To date this has happened only to aircraft that have had rough field operations.

If there are cracks the engine and mount must be removed to have Vans-supplied reinforcement pieces welded in place to reinforce the socket. For most owners this will mean that the mount must be removed from the engine to be sent out for "precision welding".
