Altimeter Tune Up

RAA

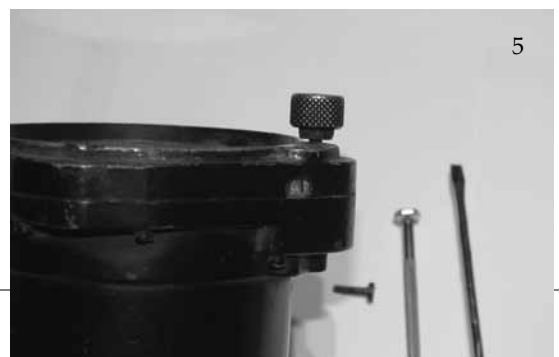
Fig 5: re-engage the gear and push the lockpin back in place. Ensure that the threaded hole is aligned to receive the screw. On this altimeter the slot aligns with the axis of the threaded hole.

Gently push the knob back in to engage the altimeter geartrain. You might have to wiggle it slightly. Once it is home you can push the retaining pin back in, and check that the knob can no longer be pulled out. Set the pin's slot to position the threaded hole and gently refit the face screw.
